**Flood Control Project Maintenance  
Levee Inspections**

**Maintenance Issue Types Only, Levee Inspection Report By Mile - Fall 2016**

**Reclamation District No. 2060 Hastings**

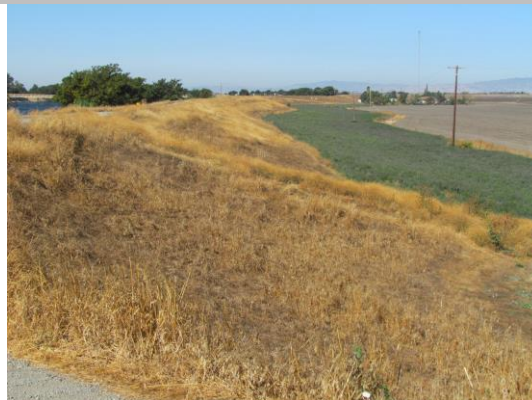
Photo 1 of 1 : FA\_2016\_RD2060\_241\_5\_20160920\_00006.jpg

LM Start	0.00	Rating **	M	Issue No.	5
LM End	5.08	Issue Type +	Ma	Location *	LS
Category	Earthen Levee		GPS Latitude/Longitude		
			Start	End	
Item	Vegetation		38.247342°	38.263293°	
			-121.696283°	-121.771557°	
DWR ID	DWR_RD2060_01_f_2016_5				
Comment Code					
V1 : Control annual grass and weeds on the levee slopes and easements.					
Inspector Comment					
Landside levee slope has been sprayed, sprayed grasses has not been removed from slope.

RD 2060 Landside slope looking downstream from levee mile 0.00.

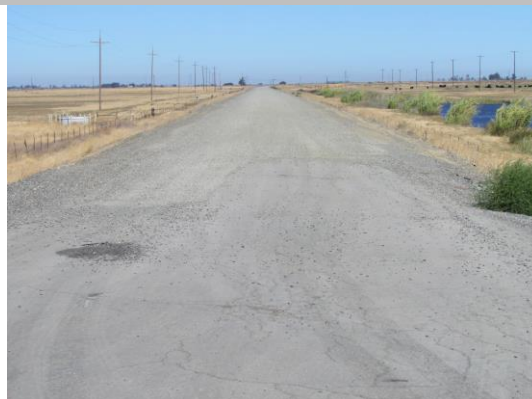
Photo 1 of 1 : FA\_2016\_RD2060\_242\_8\_20160920\_00010.jpg

LM Start	0.01	Rating **	A	Issue No.	8
LM End	3.64	Issue Type +	Ma	Location *	LS
Category	Earthen Levee			GPS Latitude/Longitude	
				Start	End
Item	Vegetation			38.275082 °	38.296645 °
				-121.794938 °	-121.748772 °
DWR ID	DWR_RD2060_02_f_2016_8				
Comment Code					
V1 : Control annual grass and weeds on the levee slopes and easements.					
Inspector Comment					
There are no unwanted weeds or vegetation on the levee section both waterside and landside.

Looking downstream from levee mile 0.01 Unit 2 RD 2060.

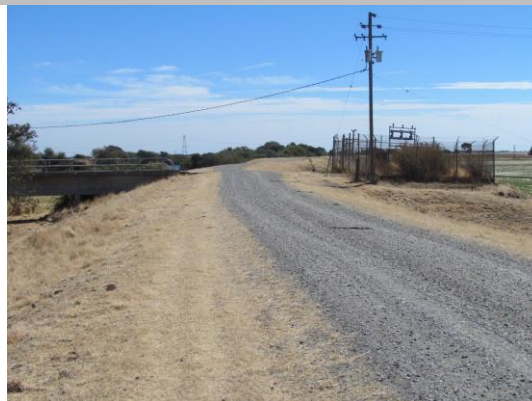
Photo 1 of 1 : FA\_2016\_RD2060\_243\_13\_20160920\_00016.jpg

LM Start	0.01	Rating **	A	Issue No.	13
LM End	3.50	Issue Type +	Ma	Location *	LS
Category	Earthen Levee			GPS Latitude/Longitude	
				Start	End
Item	Vegetation			38.296638 °	38.267223 °
				-121.748655 °	-121.702818 °
DWR ID	DWR_RD2060_03_f_2016_13				
Comment Code					
V1 : Control annual grass and weeds on the levee slopes and easements.					
Inspector Comment					
No unwanted vegetation on the levee slopes.

RD 2060 Looking downstream from levee mile 0.01 waterside slope.

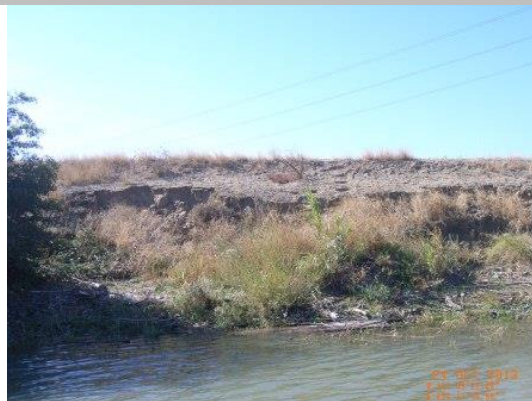
Photo 1 of 1 : FA\_2016\_RD2060\_243\_8\_20160913\_00007.jpg

LM Start	1.52	Rating **	M	Issue No.	8
LM End	1.74	Issue Type +	Ma	Location *	WS
Category	Supplemental			GPS Latitude/Longitude	
				Start	End
Item	2015 USACE Erosion Survey, DRAFT			38.288598°	38.286051°
				-121.725184°	-121.722818°
DWR ID	DWR_RD2060_03_s_2016_8				
Comment Code					
Inspector Comment					
Site added in 1997 and removed in 2003. 2005 - Put back in the inventory. 2006 - Stone repair at the middle of the site. 2011 - Some rock place at toe in the past year. 2013 - Site extended both upstream and downstream to include new erosion pockets. 2015: No observed changes. [2015 Site ID: CHS_23-6_R]

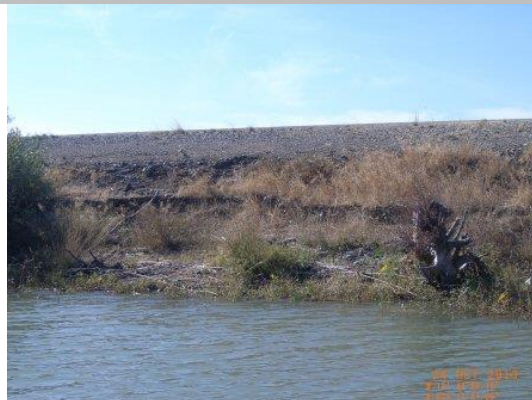
Photo 1 of 1 : FA\_2016\_RD2060\_243\_1\_20160913\_00001.jpg

LM Start	2.02	Rating **	M	Issue No.	1
LM End	2.08	Issue Type +	Ma	Location *	WS
Category	Supplemental			GPS Latitude/Longitude	
				Start	End
Item	2015 USACE Erosion Survey, DRAFT			38.284105 °	38.283302 °
				-121.718471 °	-121.717814 °
DWR ID	DWR_RD2060_03_s_2016_1				
Comment Code					
Inspector Comment					
2010 - Small maintenance site. 2015: No observed changes. [2015 Site ID: CHS_23-0_R]

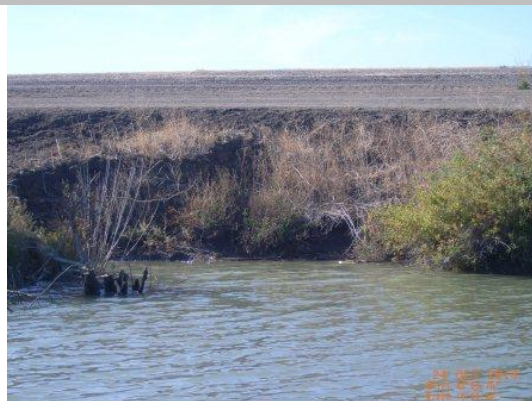
Photo 1 of 1 : FA\_2016\_RD2060\_243\_7\_20160913\_00006.jpg

LM Start	2.18	Rating **	M	Issue No.	7
LM End	2.23	Issue Type +	Ma	Location *	WS
Category	Supplemental			GPS Latitude/Longitude	
				Start	End
Item	2015 USACE Erosion Survey, DRAFT			38.282100 °	38.281510 °
				-121.716817 °	-121.716319 °
DWR ID	DWR_RD2060_03_s_2016_7				
Comment Code					
Inspector Comment					
2007 - Geotechnical failure of midside slope and wave wash/scalloping in toe area. Stone revetment upstream and downstream of site. Similar sites are present all along the right bank downstream of this site, most could be repaired with some maintenance. 2010 - Minor new erosion. 2015: No observed changes. [2015 Site ID: CHS_22-8_R]

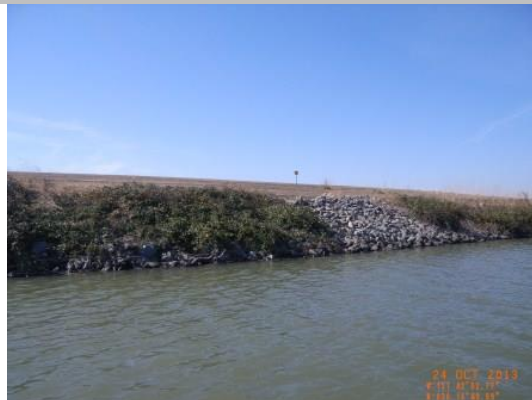
Photo 1 of 1 : FA\_2016\_RD2060\_243\_4\_20160913\_00003.jpg

LM Start	2.35	Rating **	M	Issue No.	4
LM End	2.53	Issue Type +	Ma	Location *	WS
Category	Supplemental			GPS Latitude/Longitude	
				Start	End
Item	2015 USACE Erosion Survey, DRAFT			38.280377 °	38.278306 °
				-121.714633 °	-121.712722 °
DWR ID	DWR_RD2060_03_s_2016_4				
Comment Code					
Inspector Comment					
2008 - Small scour pockets and mid-slope wave wash. 2010 - More vegetation growth, could be fixed through maintenance. 2011 - Site extended downstream and new erosion. 2015: No observed changes. [2015 Site ID: CHS_22-6_R]

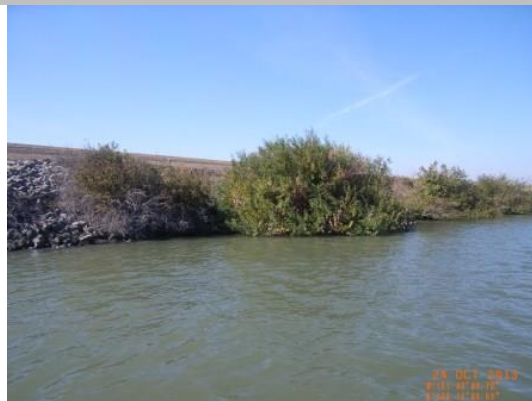
Photo 1 of 1 : FA\_2016\_RD2060\_243\_5\_20160913\_00004.jpg

LM Start	2.55	Rating **	M	Issue No.	5
LM End	2.58	Issue Type +	Ma	Location *	WS
Category	Supplemental			GPS Latitude/Longitude	
				Start	End
Item	2015 USACE Erosion Survey, DRAFT			38.278145°	38.277774°
				-121.712609°	-121.712137°
DWR ID	DWR_RD2060_03_s_2016_5				
Comment Code					
Inspector Comment					
2013 - Erosion pockets into the levee toe. 2015: Erosion pockets have increased in size. [2015 Site ID: CHS_22-5_R]

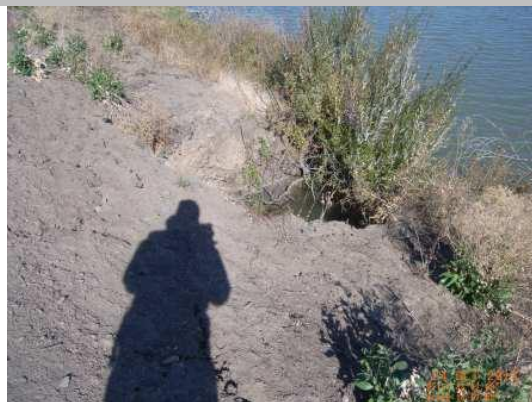
Photo 1 of 1 : FA\_2016\_RD2060\_243\_6\_20160913\_00005.jpg

LM Start	2.79	Rating **	M	Issue No.	6
LM End	2.79	Issue Type +	Ma	Location *	LS
Category	Earthen Levee			GPS Latitude/Longitude	
				Start	End
Item	Slope Stability			38.275302°	38.275302°
				-121.710130°	-121.710127°
DWR ID	DWR_RD2060_03_s_2016_6				
Comment Code					
S1 : Repair slope instability.					
Inspector Comment

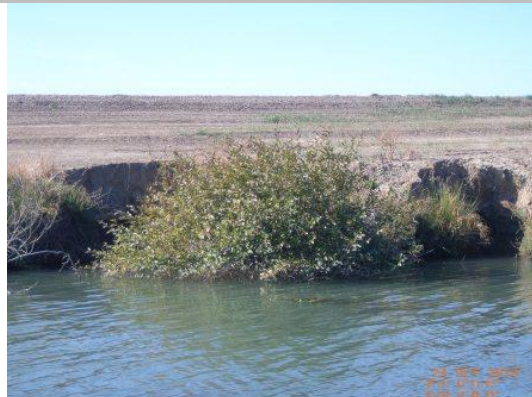
Photo 1 of 1 : FA\_2016\_RD2060\_243\_2\_20160913\_00002.jpg

LM Start	3.78	Rating **	M	Issue No.	2
LM End	4.09	Issue Type +	Ma	Location *	WS
Category	Supplemental			GPS Latitude/Longitude	
				Start	End
Item	2015 USACE Erosion Survey, DRAFT			38.264585 °	38.260593 °
				-121.698868 °	-121.696403 °
DWR ID	DWR_RD2060_03_s_2016_2				
Comment Code					
Inspector Comment					
2011 - Several pockets of erosion from rotational failure and slumping toe. 2013 - Site extended downstream to include new erosion pockets. 2015: No observed changes. [2015 Site ID: CHS_21-1_R]
